# **The Swash Channel Wreck**

## An Archaeological Investigation of a 17th-Century Armed Dutch Merchantman

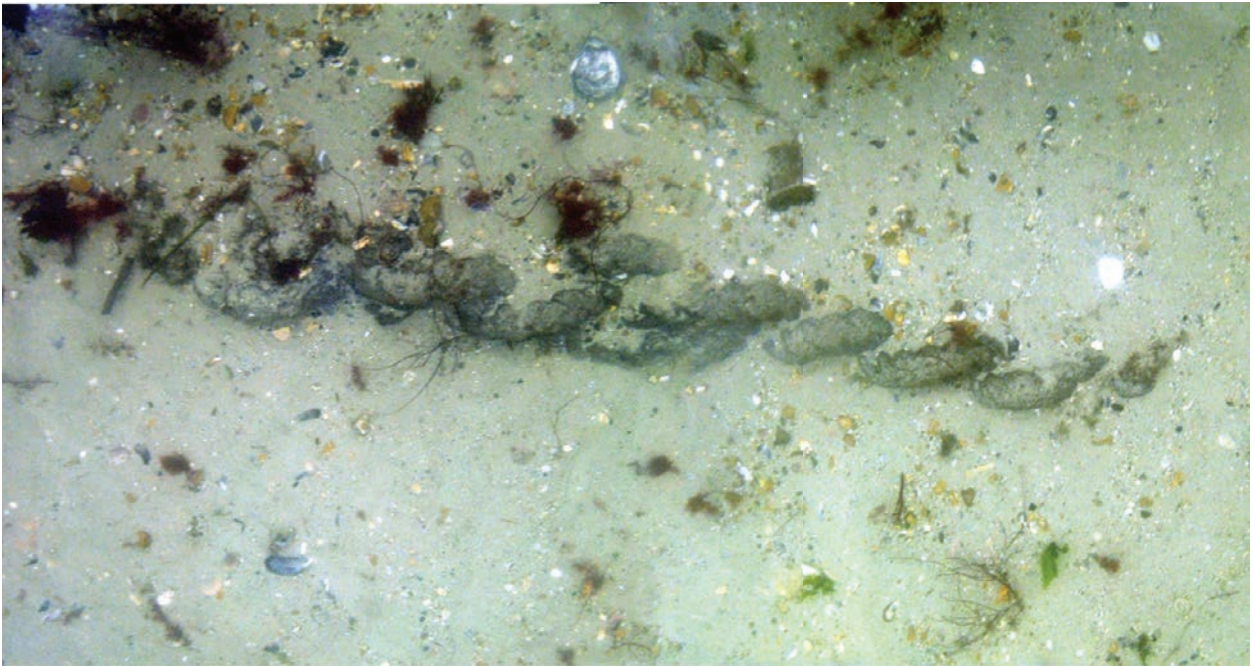
Figure 1.3. Cable potentially relating to the salvage

into the wreck to catch the deck beam. The tide would be allowed to ebb whilst the ropes to the boat would be gradually tightened. At low water the rope would be 'bar tight' (when a line is pulled up tight to the point where it has no deflection, like a bar). The flooding tide would lift the boat, thus pulling the deck out of the ship. At this point anything that was buoyant, such as barrels and loose timbers, would float up to be collected on the surface. Anything that was not buoyant would now be accessible for dragging from the surface. As the deck formed a key structural component in the ship's hull it would vastly increase the chance of the hull failing at its weakest points, the bow and the stern, allowing the sides to fall to the seabed. This could account for the present on the seabed of the port side and upperworks of the ship. A noticeable feature of the wreck when first found was the presence of a large (*c* 200mm diameter) cable on the seabed that passed under the remains of the wreck's bow (Figure 1.3). This did not survive to the excavation stage of the project but the fact it ran beneath the hull may indicate that it was involved in salvage activity.

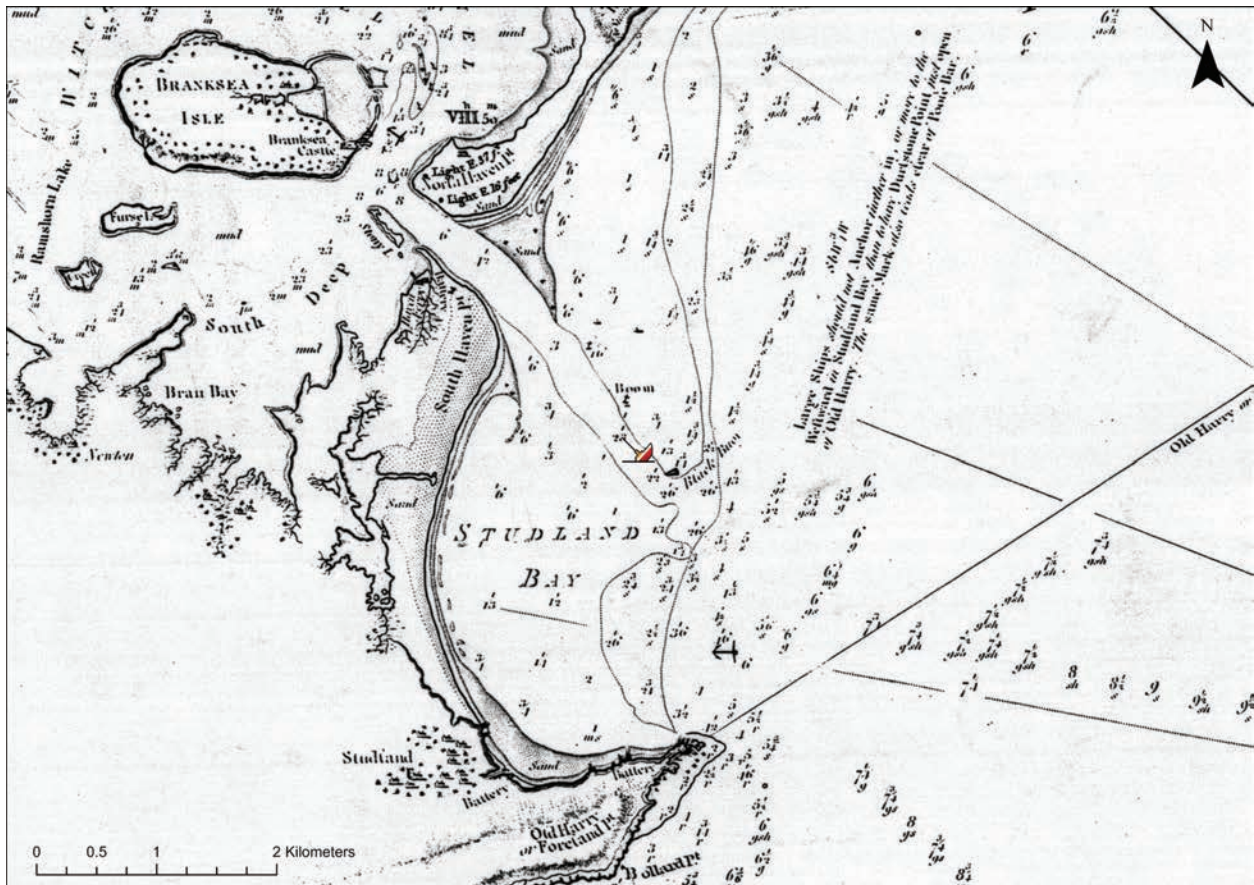
Figure 1.4. McKenzie (1785) Admiralty Chart of Studland Bay from 1785 showing the anchorage and approximate position of the wreck (note the depths are in feet)

to the Swash Channel silting up. In the 17th century, the main channel into Poole Harbour featured a bar with depths between 10ft (c 3m) and 16ft (c 4.8m) (Seller 1671, 7), preventing large ships from going into Poole. Studland Bay, however, was a known as a safe anchorage providing good shelter from the prevailing south-westerly winds (Seller 1671). The bay itself is very shallow, with the depths recorded in 1785 being less than 4m at the bar and even shallower within the bay; larger ships were therefore warned not to anchor further in than the point where Durlston Point can be seen from Old Harry (Figure 1.4) (McKenzie 1785).
